RE: Possible Illicit Discharge of Sewage into the Under Air Rights Garage, New Haven, CT

August 12, 2013

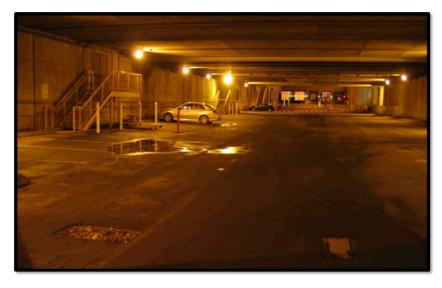
Fig. 3. Interior of the UARG, August 11, 2013. Looking westward toward the YNHH loading dock. The image was taken about 28 hours after the flooding event on August 10<sup>th</sup>.

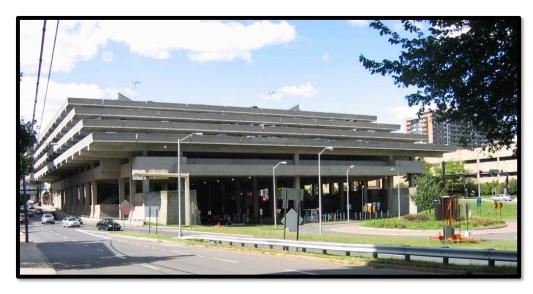
Fig. 4. Air Rights Garage and the UARG Entrance / Exit at the eastern boundary of the ARG. Photo taken in August, 2012.

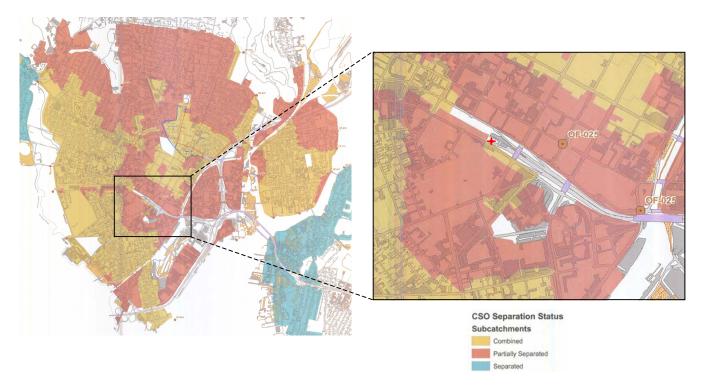
Fig. 8. Note that a red cross was added to the map to depict the location of CSO-031 which is not otherwise identified. Image Source: <a href="http://www.gnhwpca.com/Userfiles/EJPPP\_Final\_Report/121017\_EJPPP\_Final\_Report\_Web\_Vol\_2.pdf">http://www.gnhwpca.com/Userfiles/EJPPP\_Final\_Report\_121017\_EJPPP\_Final\_Report\_Web\_Vol\_2.pdf</a>

As depicted in Fig. 8 above, the region aroung the UARG is characterized by the GNHWCPA as having partial CSO separation status. But according to the Cardinal report, the majority of roof leaders from buildings are still connected to the combined system, and not the upgraded storm sewer.

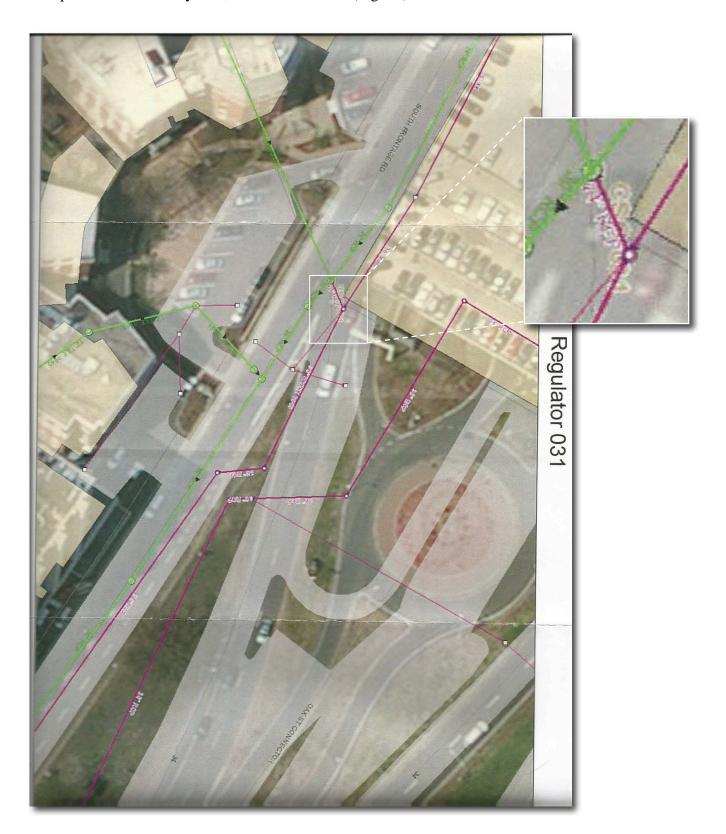
However, given the large volume of mixed sewage and stormwater that entered into the UARG on August 10, 2012, I sought verfication that the cross connection between the combined sanitary sewer system, and the separate stormwater system, was indeed closed (Fig. 11).

Fig. 11. Close-up of CSO 031 and surrounding drainage infrastructure (provided by GNHWPCA in June 2013). Note the direction of flow within the sanitary system.

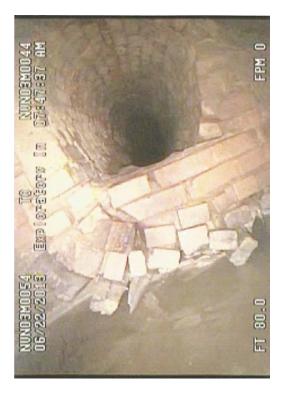
On August, 2013, the GNHWPCA provided me with images that demonstrated the cross connection at CSO 031 was in fact open, and not closed, as had been reported to DEEP (Fig. 12 & 13).

Fig. 12. CSO 031 - looking northeast toward the junction with the storm sewer system.

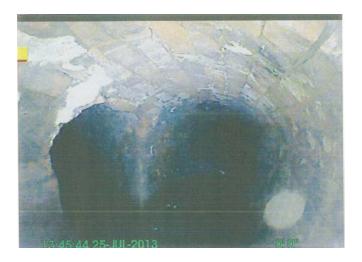
Fig. 13. The right sewer channel is looking straight into the separate storm sewer system that runs along the southern boundary of the ARG in Fig. 7 and in Fig. 11. The left sewer channel extends southwest to the other end of the CSO 031 as shown in Fig. 12.
